EXISTING/HISTORY/HERITAGE

- St Stephen's Church, initially known as St Luke the Less
- First consecrated in 1900, built to serve a growing community and to supplement the existing St Luke's church at High Orchard

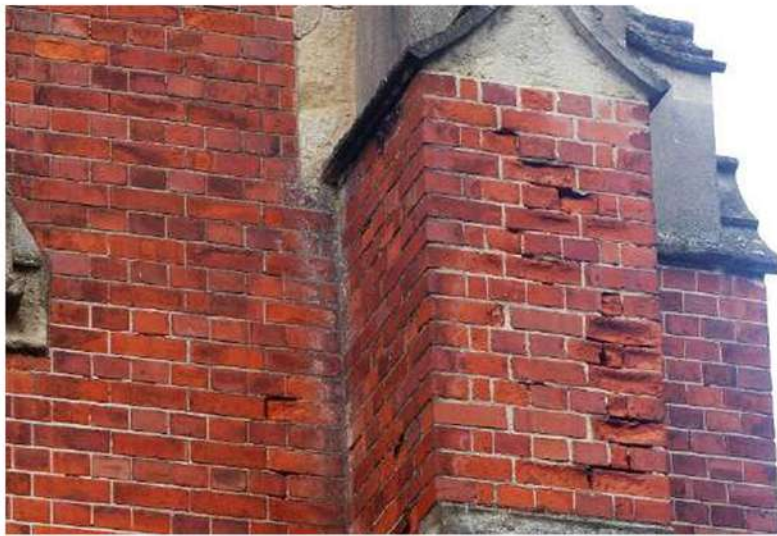
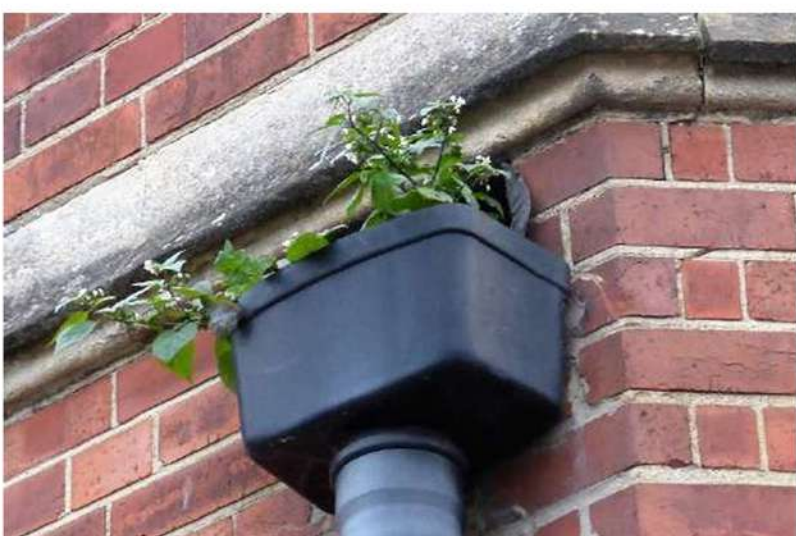
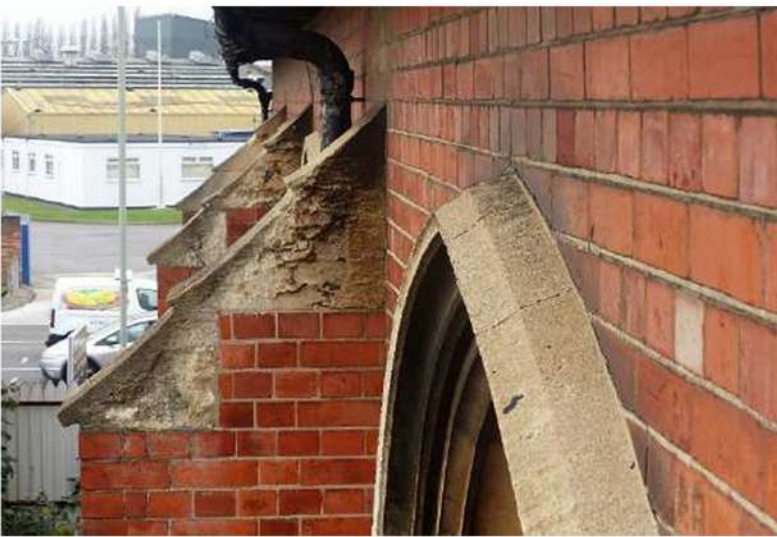
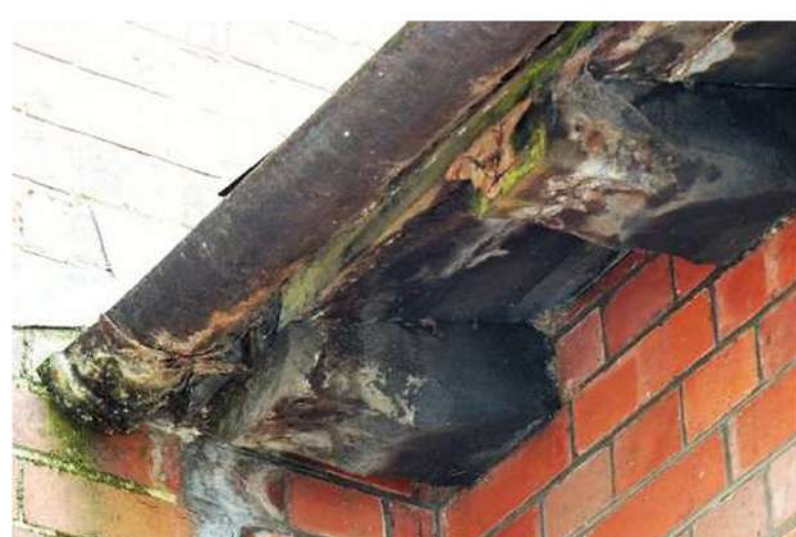
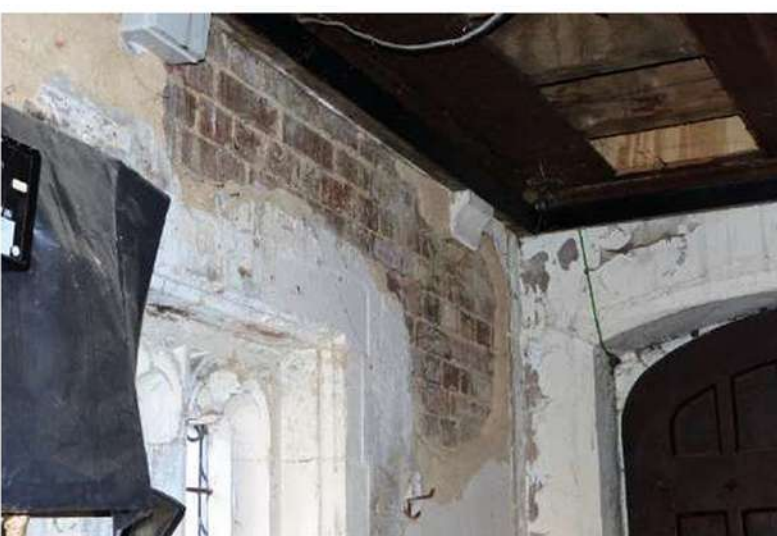
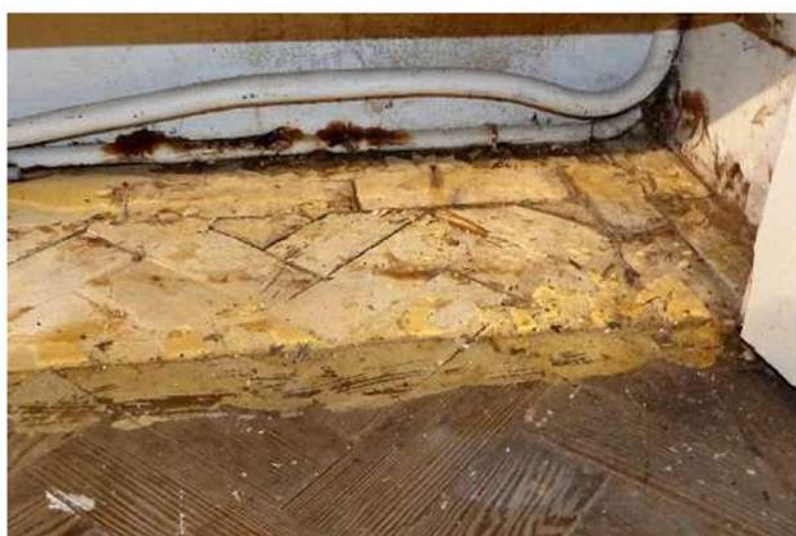
SITE INSPECTION PICTURES

- A building inspection was undertaken in 2017 as part of the optioneering process for the site, and identified:
- walls appear relatively stable, but exterior surface condition is poor in many places, notably at high- and low-level risking excessive water absorption and decay to the interior and exterior
 - defective gutters and rainwater goods
 - fungal and/or beetle decay in the timber roof structures
 - bricks and limestone dressings subject to excessive decay following extreme conditions (including air pollution)
 - lime mortar damage
 - theft (including lead theft) and vandalism is a significant problem and continued threat

In conclusion the building is in need of significant & extensive maintenance and repair, with the works required exacerbated by the 2007 floods a contributory factor in the building's current poor condition.
