EXISTING/HISTORY/HERITAGE

- St Stephen's Church, initially known as St Luke the Less
- First consecrated in 1900, built to serve a growing community and to supplement the existing St Luke's church at High Orchard

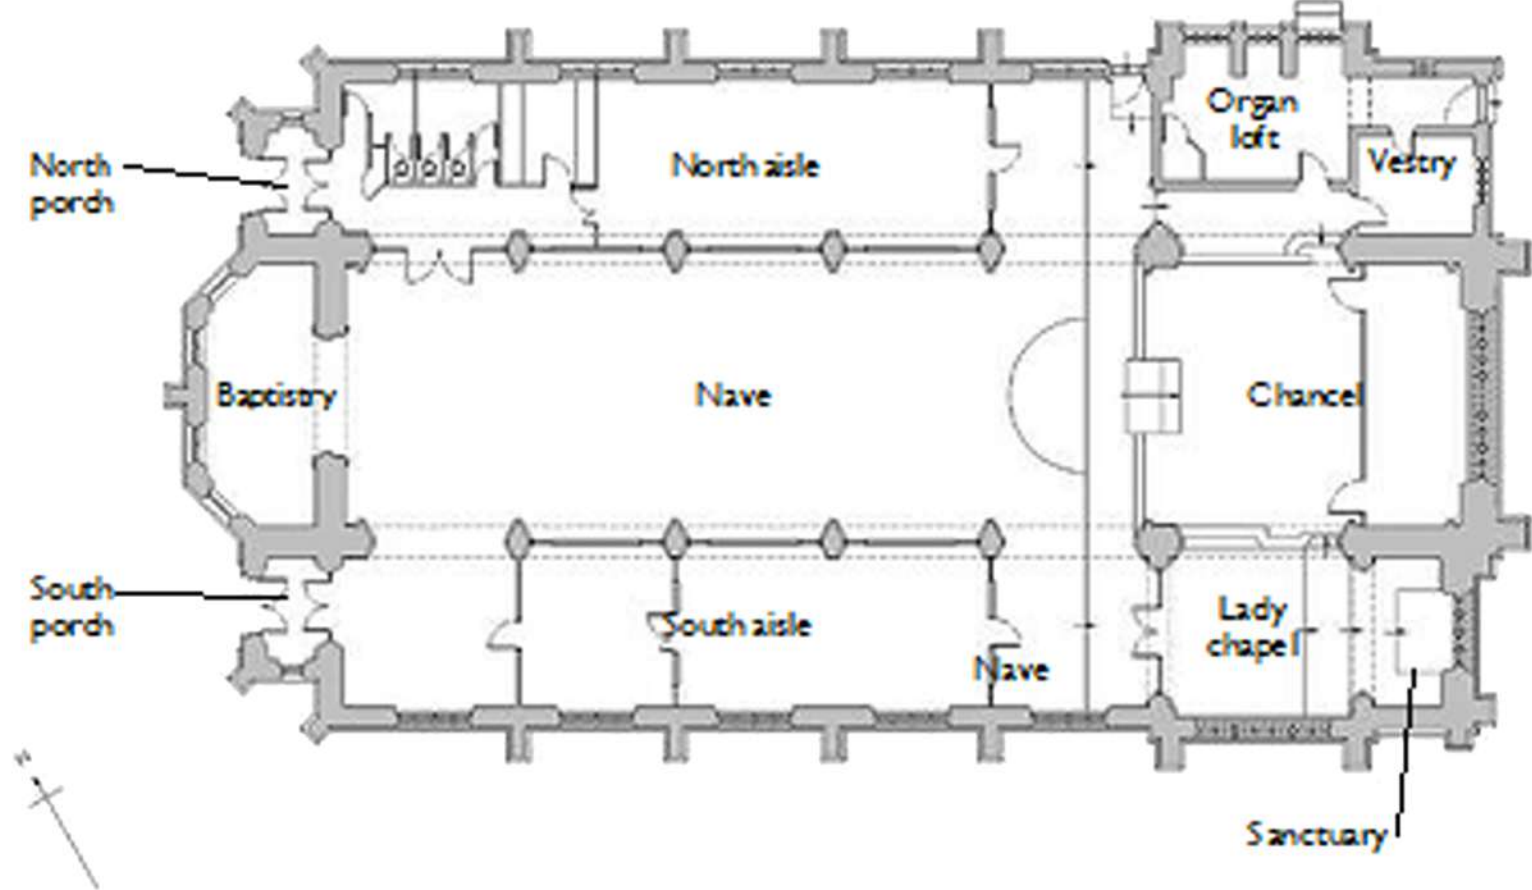
CHURCH PLAN

- A building inspection was undertaken in 2017 as part of the optioneering process for the site, and identified:
- walls appear relatively stable, but exterior surface condition is poor in many places, notably at high- and low-level risking excessive water absorption and decay to the interior and exterior
 - defective gutters and rainwater goods
 - fungal and/or beetle decay in the timber roof structures
 - bricks and limestone dressings subject to excessive decay following extreme conditions (including air pollution)
 - lime mortar damage
 - theft (including lead theft) and vandalism is a significant problem and continued threat

In conclusion the building is in need of significant & extensive maintenance and repair, with the works required exacerbated by the 2007 floods a contributory factor in the building's current poor condition.
